**Monitoring of the Health and Fish Passage Issues of Healey's  
Lagoon Following Removal of an Extensive Mat of Floating  
Aquatic Weeds**

Report No. 06/11

June 2006

Australian Centre for Tropical Freshwater Research  
James Cook University  
Townsville, Qld 4811

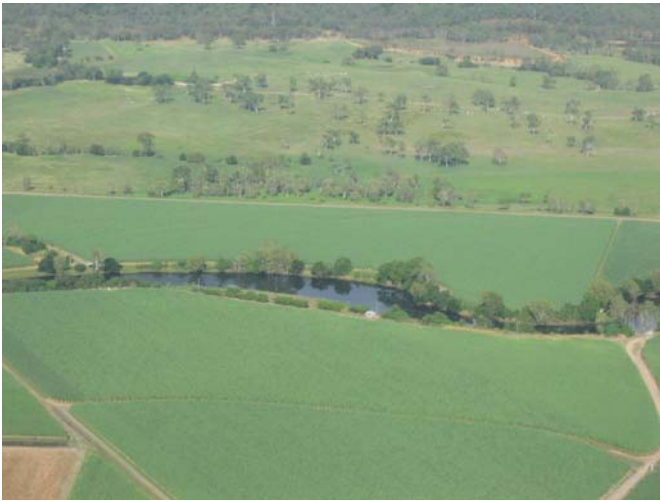
Figure 1: Middle section of Healey's Lagoon (Photo: Jim Tait)

Healey's Lagoon is a linear lagoon (Figure 1) retained entirely within an old river channel. It is approximately 5km long and runs in an essentially north-south direction. A survey of the riparian vegetation in December 2004 (Dowe 2004) showed that Healey's Lagoon retains a narrow but relatively good condition strip of dense riparian vegetation, one of the best remaining within the developed Burdekin-Haughton floodplain. Ironbark Creek retains a similarly good condition riparian zone. Paragrass is prevalent along the waters edge, especially in areas where riparian shading is restricted. The persistently high waters levels and mostly intact riparian strip have helped to reduce the invasiveness of paragrass along Healey's Lagoon, compared to many other waterbodies in the Burdekin-Haughton floodplain.

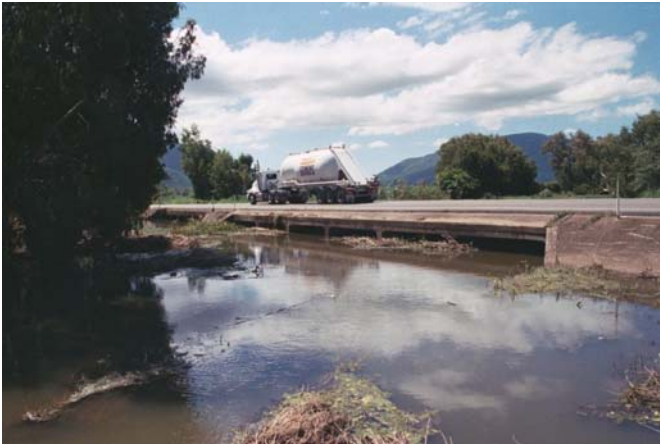
Figure 3: Highway culvert downstream from Healey's Lagoon

It was hoped that with the relatively large size of the January 2005 flood event and the removal of the floating weed mats during that event, that evidence of fish passage, especially of barramundi would be found. However, it was not, even though quite clearly, it has occurred in the past. The most likely cause for this is either physical inability to negotiate the road culverts under the Bruce Highway, immediately downstream of Healey's Lagoon (Figure 3), or poor water quality during flow events turning fish away from swimming upstream. Examination of the culverts during several flood events, and their construction in general, leads us to think they are not the likely cause. They are of the recommended box culvert design for improved fish passage, are

not particularly long and there are several of them. In addition, in flood events such as the 2005 event, flood water overtops the highway, as evidenced by floating weeds on the road guideposts, and fish passage would be possible over the road for a limited time.

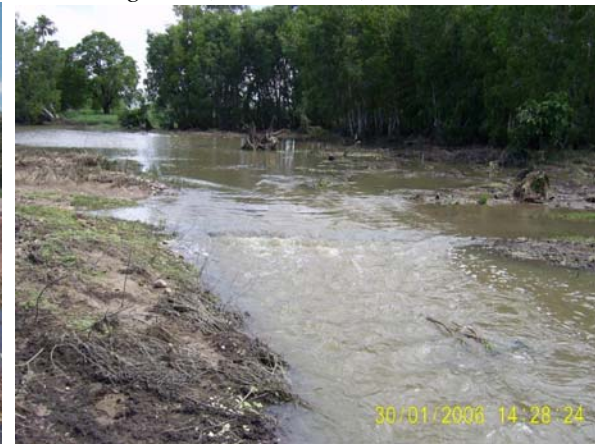
Figure 4: Outlet to Healey's Lagoon showing restricted fish passage on low flows

Sampling on 2 Feb followed continued warm, sunny to overcast days. Run-off continued to slow and most of the run-off was the result of slow drainage of shallow ground water and ponded surface water. The outlet to Healey's Lagoon was an effective barrier to small fish schooling below in the pool that extends under the road culvert (Figure 4). There was no smell of H<sub>2</sub>S. Water was still flowing at the entrance to Reed Beds Lagoon. The water was opaque black and still smelt of H<sub>2</sub>S although the strength had diminished since 30 Jan. There was no visible sign of fish although large tadpoles

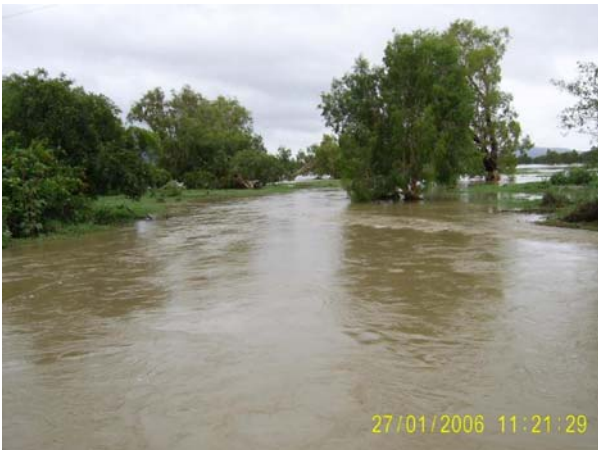
Figure 5: Turbid water flowing downstream from Healey's Lagoon on 27/1/06

Sampling on 27 Jan followed heavy rainfall on 26 Jan and the run-off was on the early part of the tail of the hydrograph. The water looked turbid but no turbidity measurements were taken (Figures 5 and 6). Fish species identified at and above the highway crossing included *Ambassis agrammus*, *Craterocephalus stercusmuscarum*, *Hypseleotris klunzingeri*, *Melanotaenia splendida* and an eel, probably *Anguilla reinhardtii*. Generally, water quality was suitable for all native fish species at all locations, although DO dropped from ~65% sat. at the outlet of Healey's Lagoon to 42.5% sat. at the inlet to Reed Beds Lagoon. There was no smell of H<sub>2</sub>S at either location.

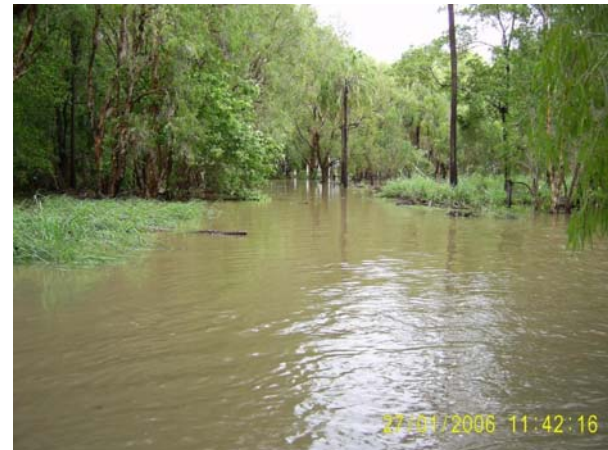
Figure 6: Water flooding into Reed Beds Lagoon across a wide area on 27/1/06

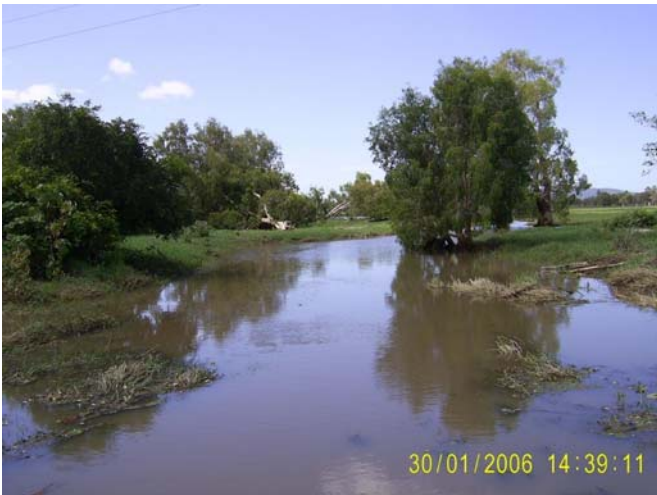
*Figure 7: Reduced water flow across cattle paddock downstream from Healey's Lagoon on 30/1/06*

Sampling on 30 Jan followed a period of warm, sunny to overcast days with low rainfall that did not add to flow events measurably. The hydrograph was slowing and flow rates were greatly reduced compared with 27 Jan. Water quality at Healey's Lagoon outlet was still acceptable with DO at ~42% sat. There was no smell of H<sub>2</sub>S at the outlet to Healey's Lagoon and fish fingerlings were visible at a number of places immediately upstream and downstream from the highway. At the inlet to Reed Beds DO was 4.2% sat. and the smell of H<sub>2</sub>S was strong. The water was visibly clearer than at the outlet to Healey's Lagoon and was an opaque dark grey colour (Figure 8). There was no visible sign of fish at this site. The low DO reading is likely to severely stress most native fish species and the impact of H<sub>2</sub>S is still unknown but is indicative of unfavourable conditions.

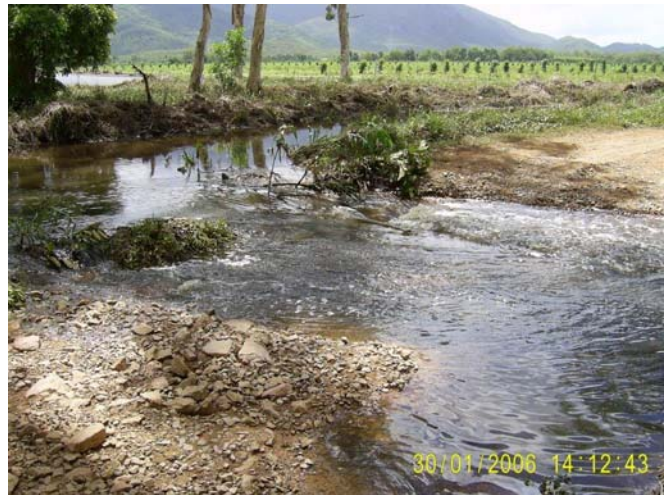
*Figure 8: Water draining from cattle paddock into Reed Beds Lagoon on 30/1/06*

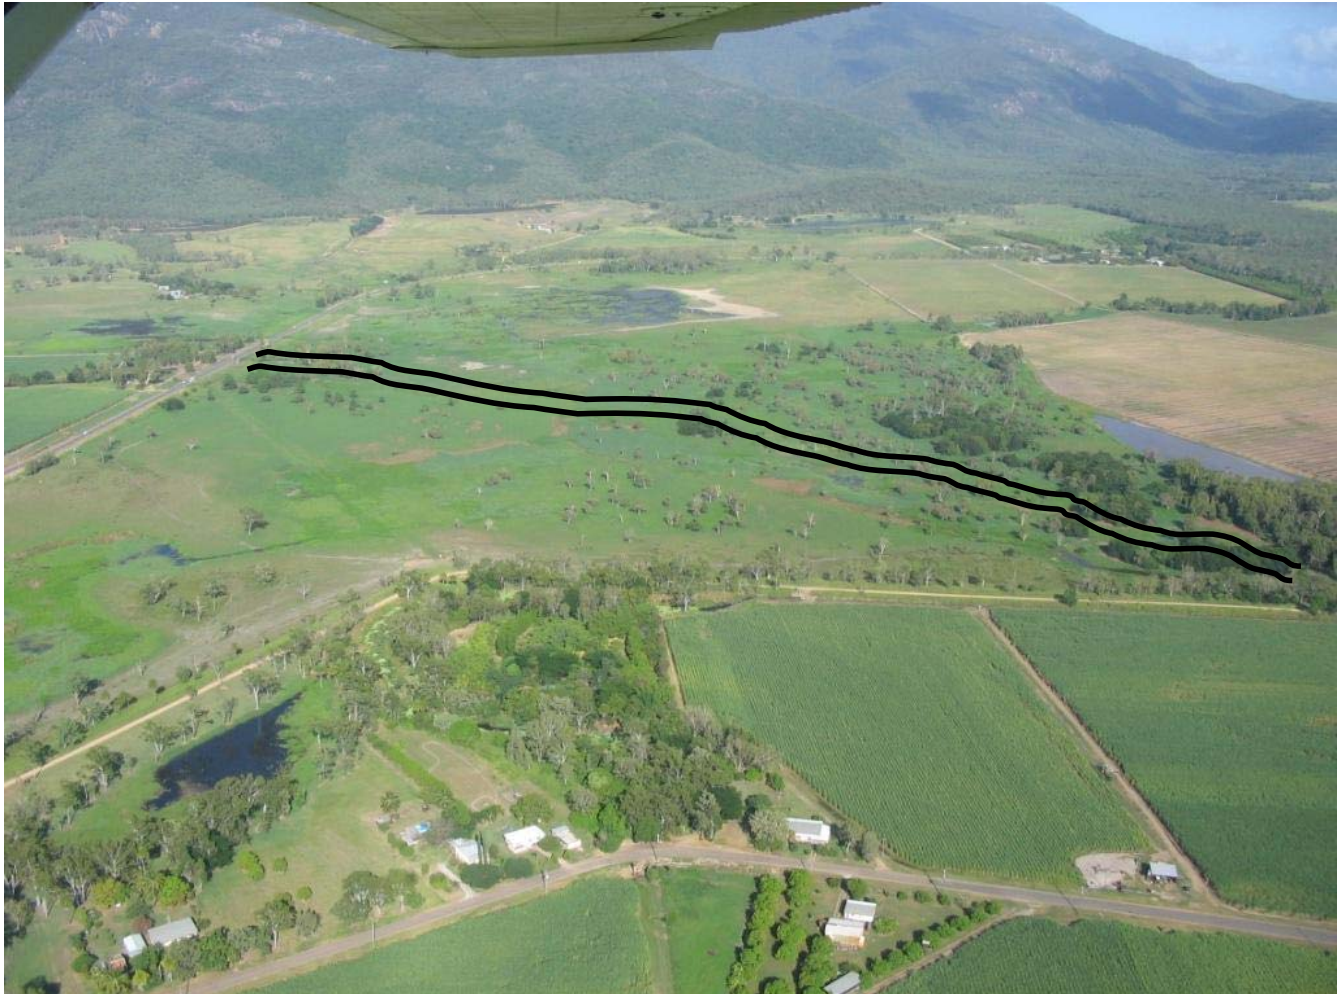
*Figure 9: Approximate proposed course of channel across cattle paddock (Photo: Jim Tait)*

The results of several fish surveys show that Healey's Lagoon has some fish passage issues and that its fish diversity and productivity is less than what would be expected of a major floodplain lagoon of its size, location and condition. There do not appear to be any physical barriers preventing fish passage. Although only a cursory examination of one flow event, it is clear that the quality of water entering Reed Beds Lagoon, specifically the dissolved oxygen content, appears to be too poor to encourage fish to migrate up this flow path into Healey's Lagoon. The DO content of the water is sufficient when it leaves Healey's Lagoon but insufficient by the time it arrives at Reed Beds Lagoon, the source of potential fish recruits. The most likely cause of the decline in DO content is oxygen demand from the soil, which consumes the oxygen in the overlying water. Where the overlying water is deep or flowing fast, the effect is lessened, but when shallow and/or flowing slower, it is heightened. During strong flows from large flood events, the residence time of water on the paddock is reduced and fish may have the opportunity to move upstream, but this only occurs for brief periods of strong flow on rare occasions. Restoration of good fish passage requires that pathways for fish passage remain viable more frequently and for longer periods. One means of achieving this in the current situation would be to construct a channel across the paddock between Healey's and Reed Beds Lagoons (Figure 9). Having a channel would allow greater separation between the water column and the soil, thus reducing the effect of the soils oxygen demand on the quality of the overlying water and making conditions for fish passage more favourable. The finding by Burrows and Tait (1998) of many fish species, including jungle perch, at the Healey's Lagoon end of the old irrigation channel that went across this paddock until 1998, shows that fish can move across this paddock under the right conditions. Anecdotally, barramundi are reported by locals to have formerly used this channel to migrate upstream (Burrows and Tait 1998).

Investigation of the channel would require consideration of the location, depth, shape and configuration (eg, presence of vegetation, installation of aeration structures) of the channel and the potential for acid sulphate soils to be disturbed as a result of the channel excavation. Consideration should also be given to the provision of snags (for fish to rest behind and hide in the water column while accessing water surface layers for oxygen intake) and riparian vegetation.
